Armstrong Dam Removal

FEASIBILITY STUDY

Monatiquot River - Braintree, Massachusetts

DECEMBER 2016

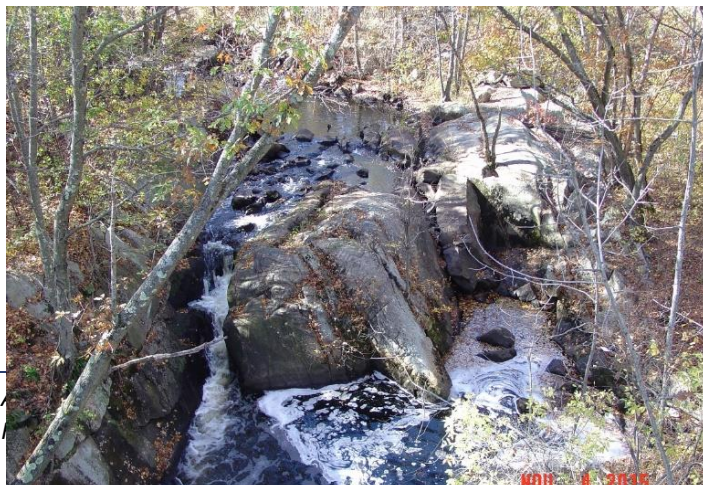
Rock Falls

Just upstream of the stone arch MBTA Railroad Bridge is Rock Falls, which represents the current upstream extent of river herring migration. It consists of a vertical drop of 4 feet over approximately

10 feet of ledge. Below the water falls is a large plunge pool just upstream of the MBTA Railroad Bridge. *Marine Fisheries* is presently investigating lowering the crest elevation of the falls as a fish passage option.

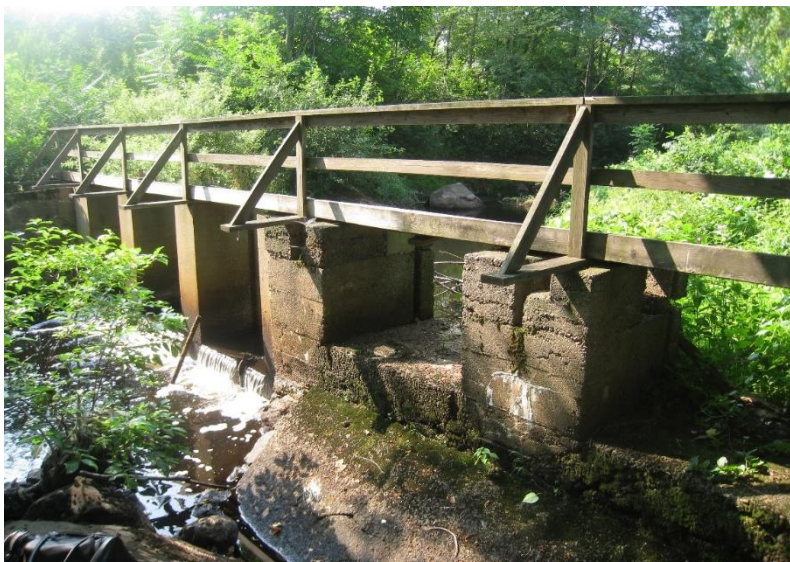
Upstream of Rock Falls is the Ames Pond Dam, which is approximately 2-3 feet high and approximately 50 feet long. It consists of seven bays; the three center bays have lower sill elevations than the two bays flanking each side of the center bays. The three center bays convey most of the flow and only under high flows is water conveyed through all of the bays. Directly below the Ames Pond Dam is a plunge pool formed by a series of rocks in a near semicircle. Only minor changes were deemed necessary to achieve river herring passage at Ames Pond Dam (GSE, 2009); however, the project now seeks full removal as part of site improvements integrated with the Armstrong Dam removal construction.

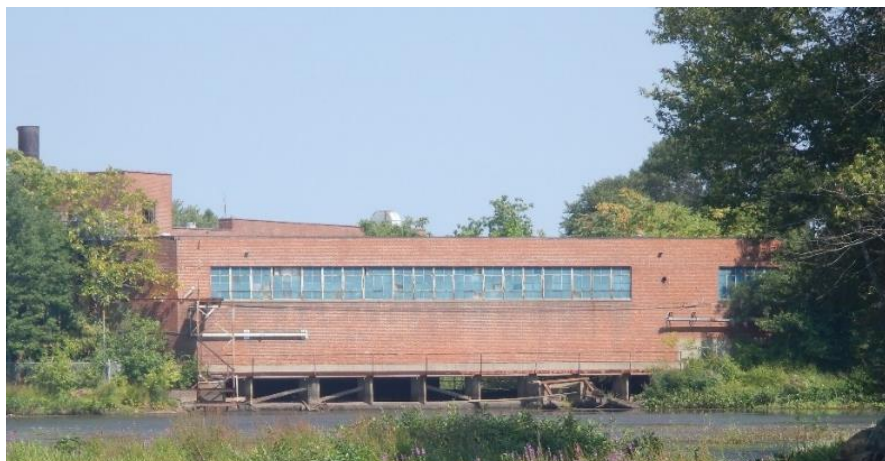
Armstrong Dam

piers also support a metal catwalk spanning the length of the dam. The opening of the bays (and the piers) vary in dimensions, but the inside to inside dimensions are on average 8 feet. There are eight main bays on the spillway and one auxiliary bay at a lower elevation.

Five feet in front of the dam, the auxiliary bay acts as a low level outlet. The outlet is a concrete box, which water spills into, leading to a four-foot diameter culvert pipe running through the dam. The low level outlet has stoplogs at its entrance (6.2 feet wide). Downstream of the dam and beneath the building, structural vertical support columns extend to the riverbed.

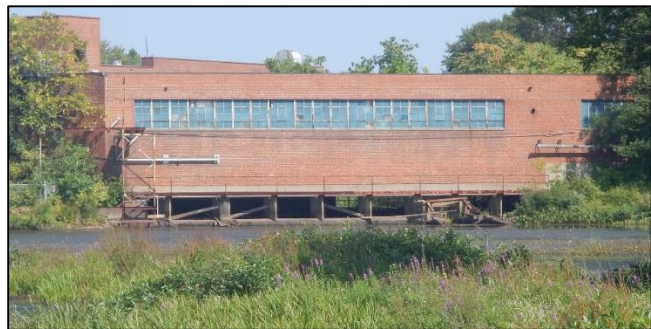
- As shown in the photo inset, there is a building owned by Messina sitting atop the dam. In fact, between each bay opening of the dam, there is vertical concrete column extending from the top of the spillway crest to the low chord of the building. Based on discussions with Messina, the future use of this site will continue to contain a river crossing, with modifications or removal of the existing building. Messina only has a limited easement to enter the property from Hancock Street over the adjacent railroad property. Consequently, the current building provides the only means for accessing the northwestern side of their property. It was assumed that three new vertical columns would span the building and extend from the low chord of the building to the bedrock channel. Gomez and Sullivan did not conduct any structural analysis to determine if three vertical columns were structurally sufficient to carry the building load to the channel bed; the columns were included solely for hydraulic modeling purposes. It is assumed that if the dam removal were to proceed

an independent structural assessment of the building would be conducted. In addition, no geotechnical investigation was conducted where the columns would be tied into the ground.

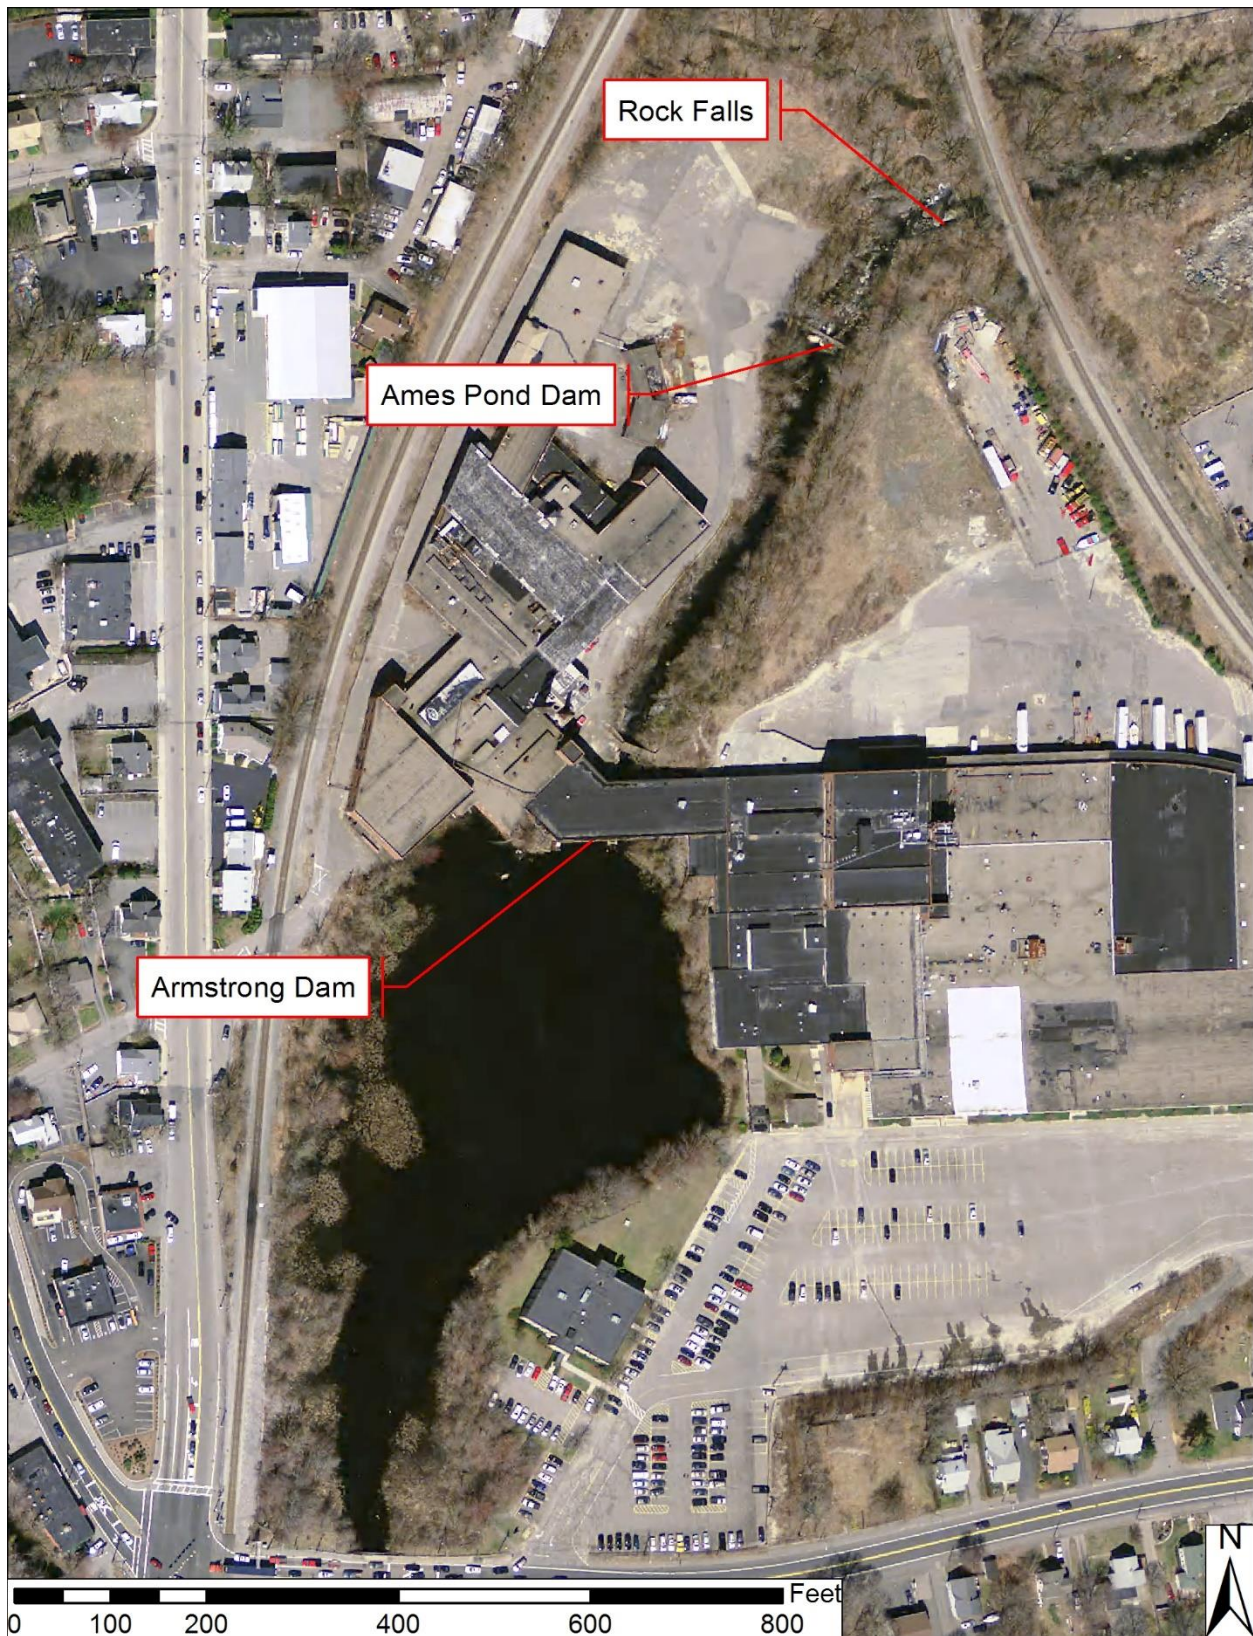
Figure 1.1-3: River Features

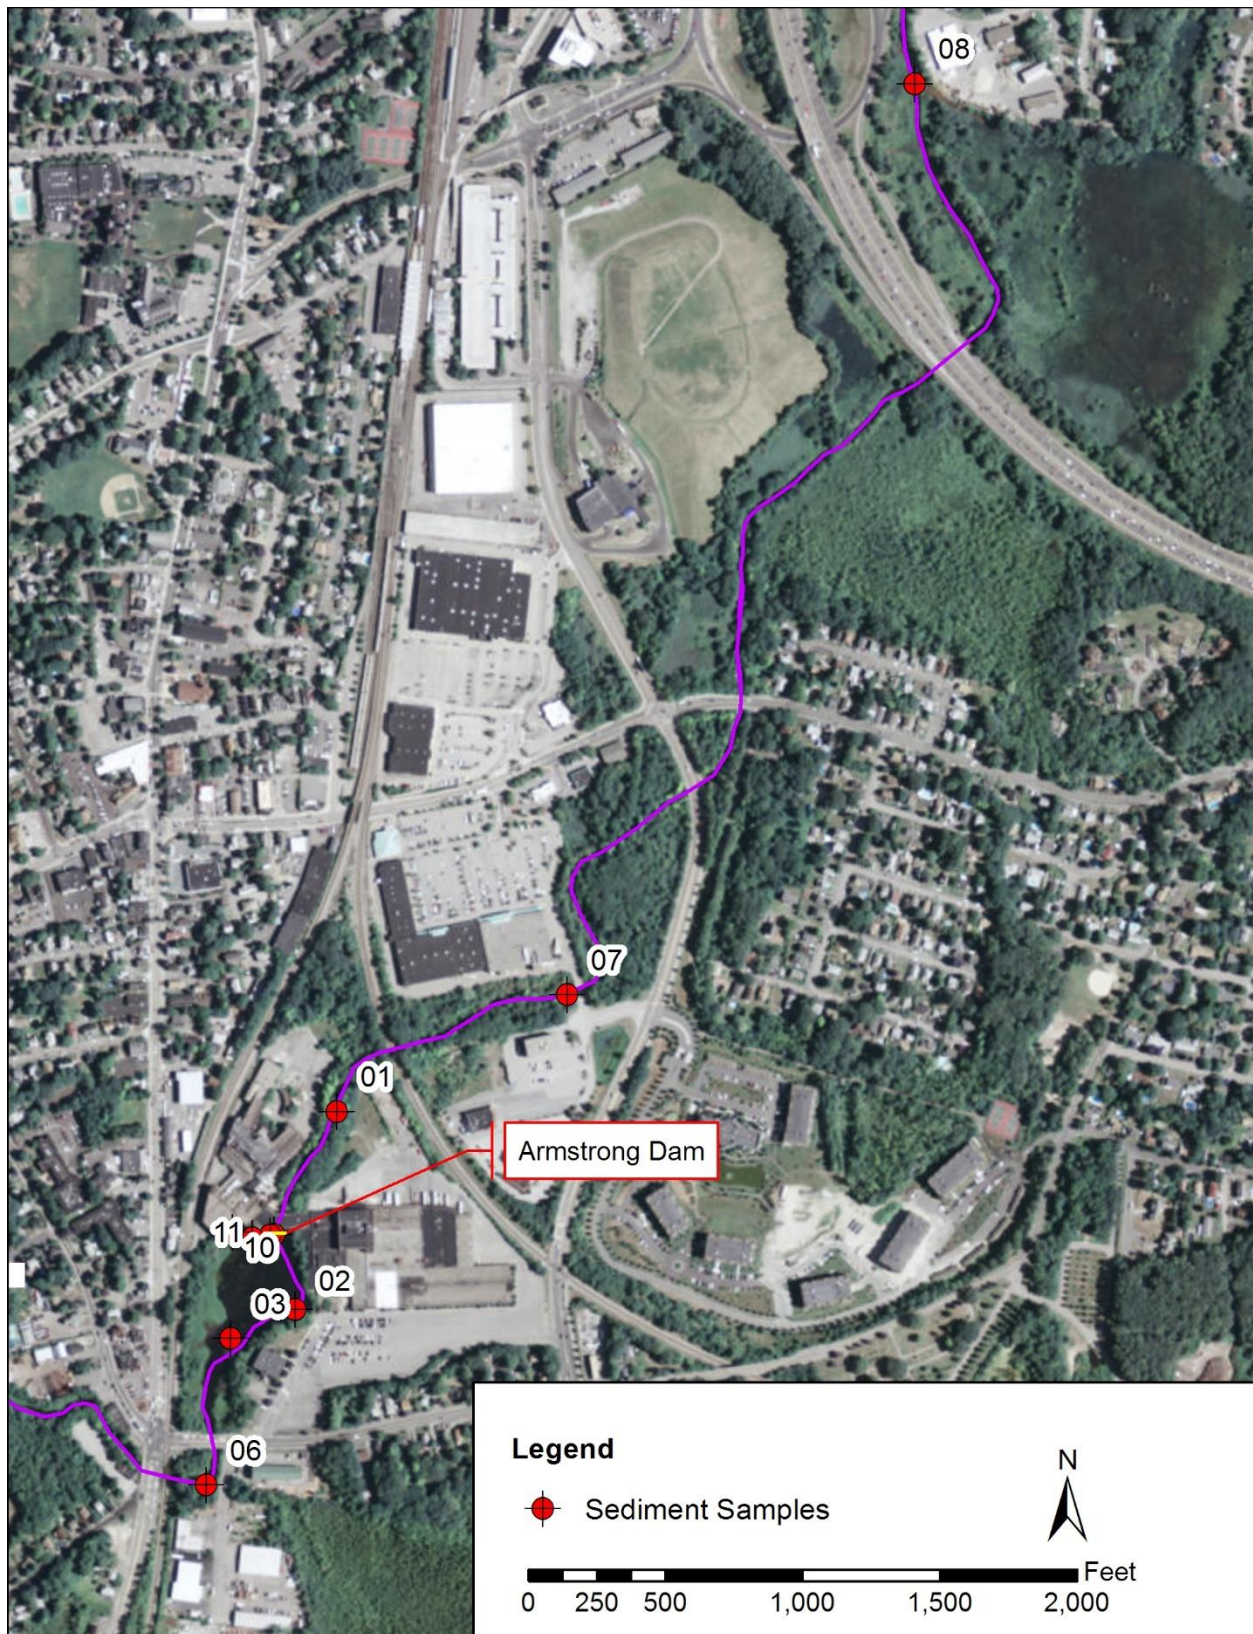
Figure 7.3-1: Downstream Sediment Sampling Location

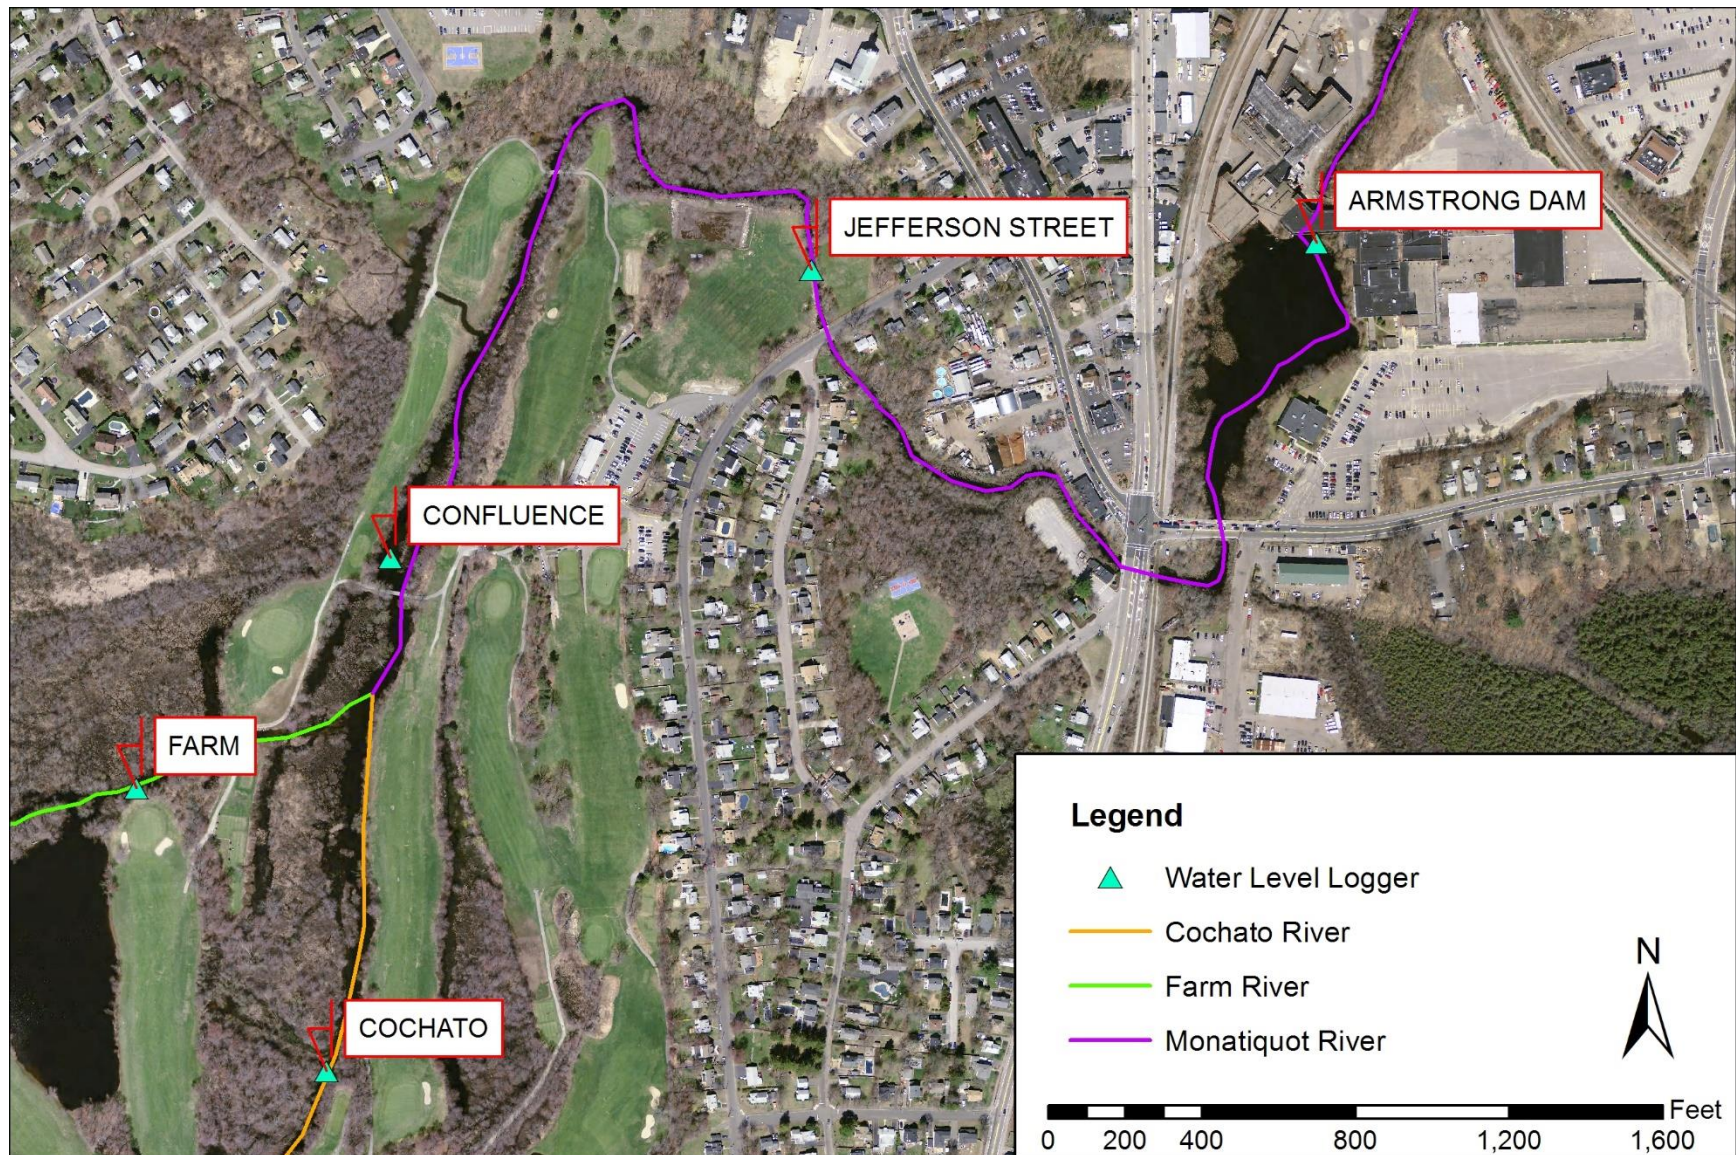
Figure 9.2-2: Water Level Logger Locations
